LITTLE BLUE RUN DAM NDI I.D. NO: PA-917 DER I.D. NO: 4-49

PHASE I INSPECTION REPORT NATIONAL DAM INSPECTION PROGRAM

#### PHASE I REPORT NATIONAL DAM INSPECTION PROGRAM

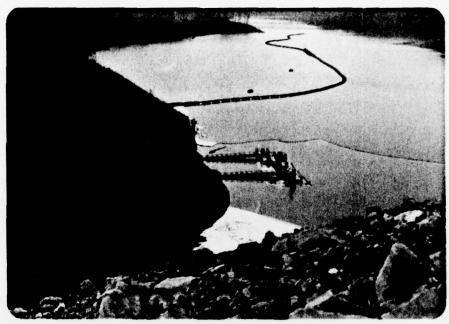
Photograph No. 1

Reservoir. Background: sludge inflow line. Foreground: effluent pump station. (Pool level about 170 feet below dam crest).

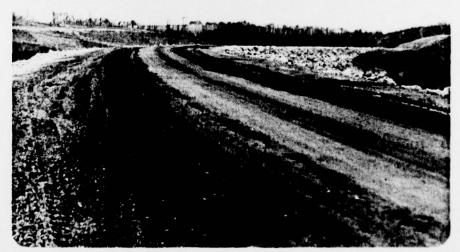
Photograph No. 2 Crest (looking west).

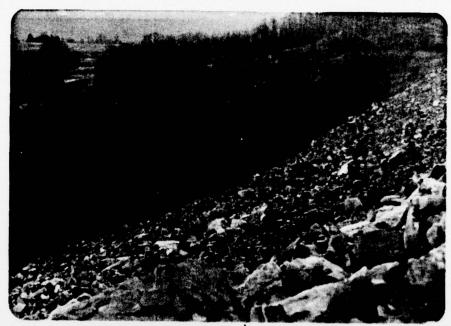
Photograph No. 3
Right abutment. Note erosion ditches.

3.2 Evaluation. The condition of the dam is considered to be good. It is recommended that the cracking problem on the crest, which appears to be due to differential settlement of the various rock zones of the embankment, should continue to be evaluated by the design engineers. Similarly, attention should be given to the slumping and seepage problem on the left abutment. Erosion ditches on the right abutment should be filled.

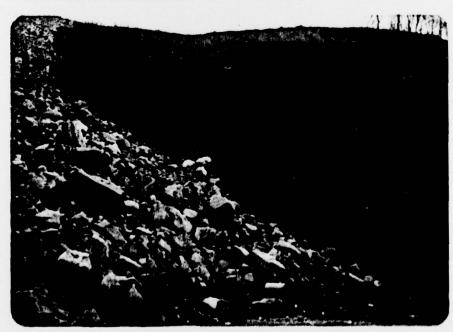
Photograph No. 4
Left abutment. Note oil barrel at the toe for scale.

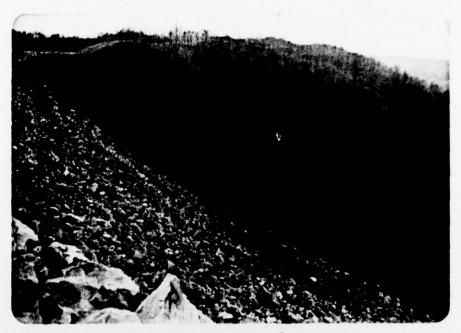
Photograph No. 5
Left abutment. View from crest.

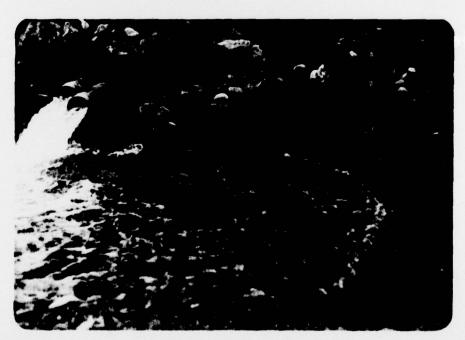
Photograph No. 6
Effluent discharge pipes left. Toe drain right.

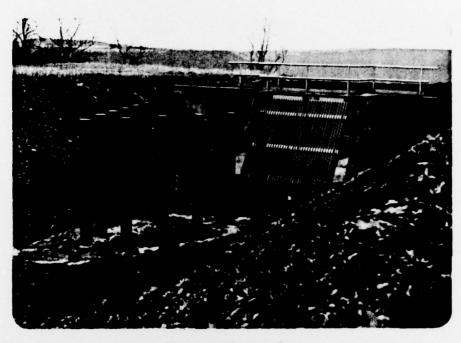
Photograph No. 7
Primary spillway intake structure.

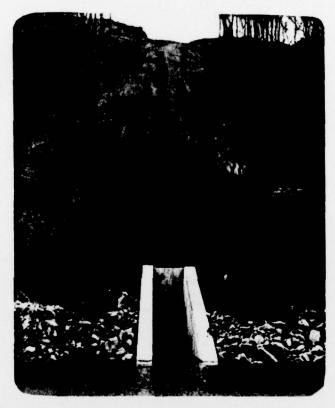
Photograph No. 8
Primary spillway discharge structure.

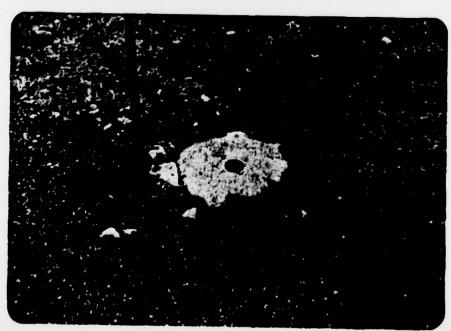
Photograph No. 10
Settlement monument on crest (typical).

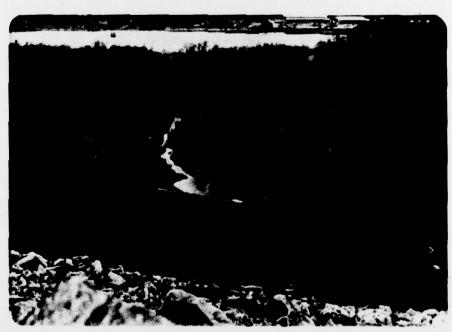
Photograph No. 12

Downstream area. Ohio River in background.
